TEST REPORT No. 5029 [Rev A]

Requested by: MITEQ
on (date): 18 August 2009
Manufacturer: MITEQ
Product Desc: Stone Impregnator and Consolidator BR128
Miteq Sealer 104
Sandstone and Basalt samples

MASONARY UNITS AND SEGMENTED PAVERS
Method 10: Determining resistance to Salt Attack

TEST CARRIED OUT IN ACCORDANCE WITH
 AS/NZS 4456.10: 2003 (Method A – Stone)

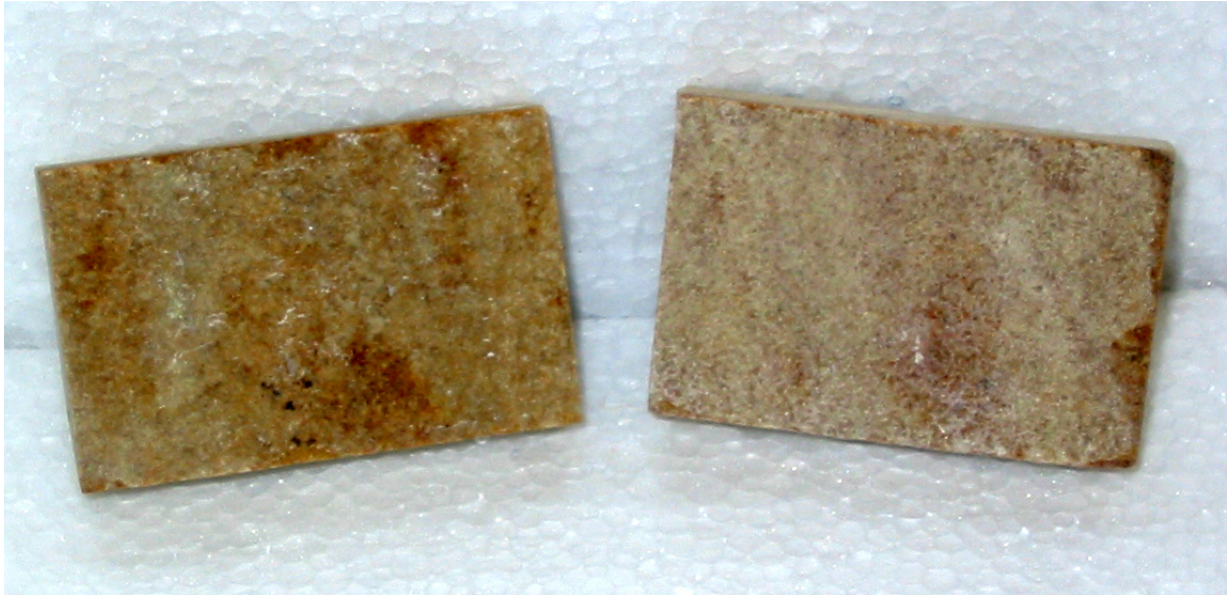
Exfoliated sandstone sample comparison
Pre and post sodium sulphate testing

The surface roughness was abraded from the upper face of the exfoliated samples.
 There was a light abrasion of the keen edge of all sandstone samples.
 The basalt was almost unaffected by the salt solution.

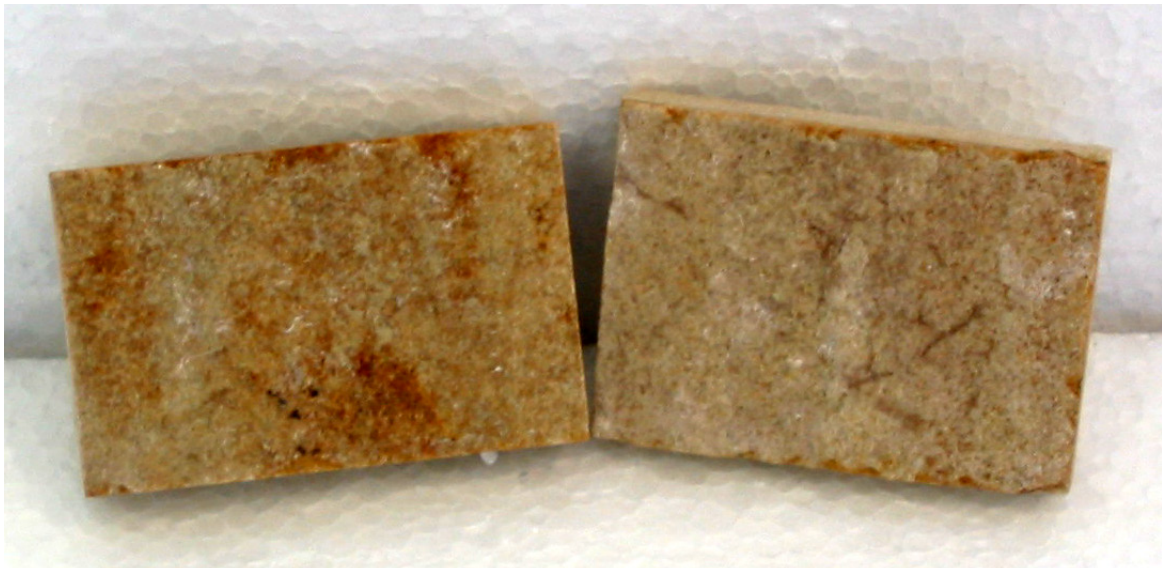
Exfoliated sandstone sample comparison
Pre and post sodium chloride

The surface roughness was abraded from the upper face of the exfoliated samples.
 There was a light abrasion of the keen edge of all sandstone samples.
 The basalt was almost unaffected by the salt solution.

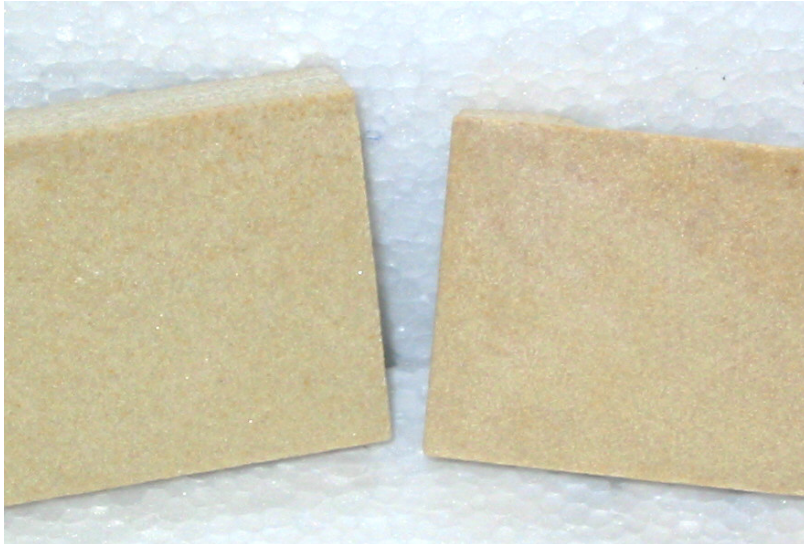
Honed sandstone sample comparison
Pre and post sodium sulphate and chloride

There was no loss of definition from the surface of these samples from either salt solution.

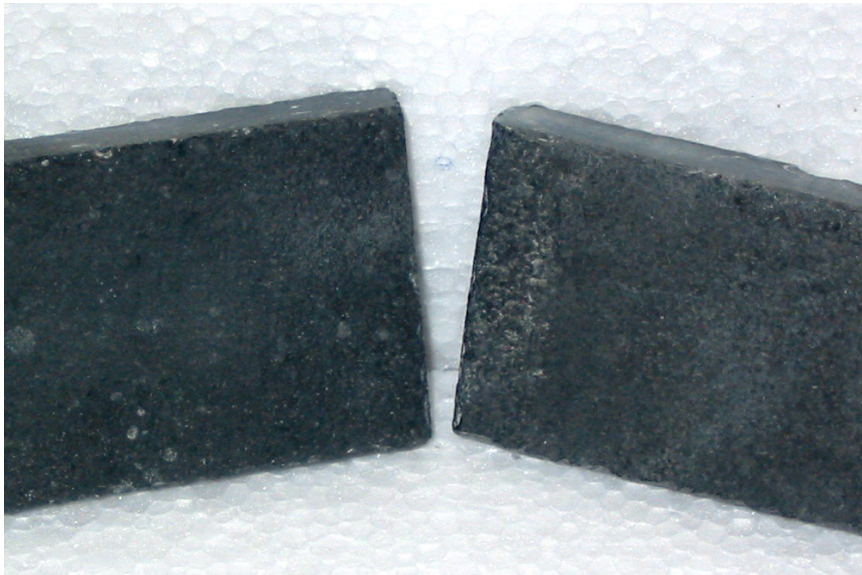
Basalt sample comparison.
Basalt samples were only mildly affected by sodium chloride.
